# MONUMENT RECORD

Corner ID: **BeBI\_K09**

## Quarter Corner

Sections 9 & 16- T10N-R02W, 2nd P.M.

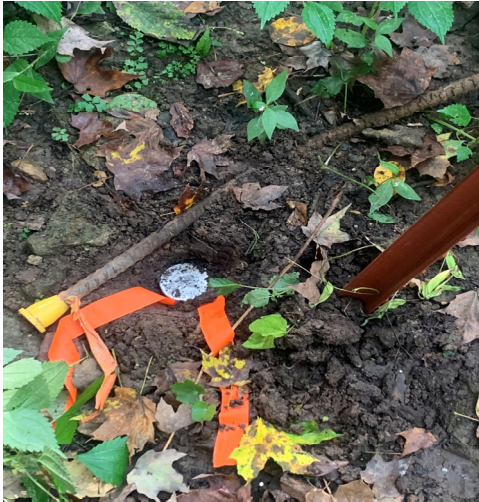
Photo Orientation & Description: From Above

Found bent rebar was removed and straight MCSO SHEPPARD capped rebar placed in the hole formed by straight section of removed rebar. GPS coordinates were established on the rebar. A steel post with MCSO SURVEY MARKER sign attached, 3.5' above ground, facing West was set 0.5' West of the rebar. 2 Rebar Lites and a mag hub nail were set within sight of the rebar, that could be used to reestablish its location, should it become obliterated. Additionally, references were made to trees, to visually aid in finding it.

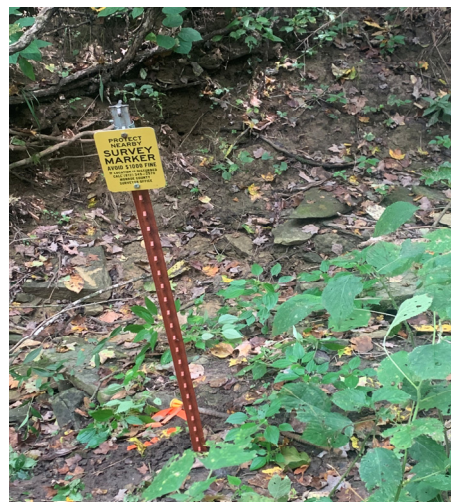
Photo Orientation & Description: From West Looking East

We reached the site by walking around a crop field on the South side of a sewage treatment plant that is accessed by a farm lane leading to Moon Road, ¼ mile South of 9494 N Moon Road. The monument is in a north-south ravine, at the West edge of a small stream ±150' South of the South bank of a large creek running generally east-west.
